Kickapoo Traditional Tribe of Texas Local Road Safety Focus Approach - Technical Assistance

Federal Highway Administration Office of Safety

August 2025

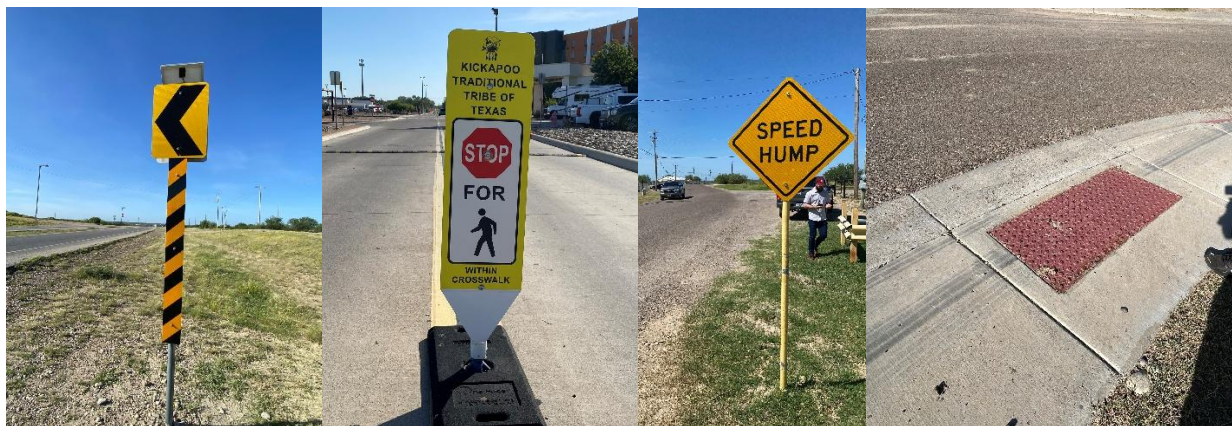
The review team noted several existing roadway safety features on multiple corridors in the study area, including the following:

- Signs are generally in good condition
- Road curve advance warning signs
- Roadside object markers
- Crosswalk pedestrian warning signs
- Speedhumps and warning signs throughout the community
- ADA sidewalk ramps
- Street lighting

Existing signage on the study corridors (Photos taken during a FHWA contract)

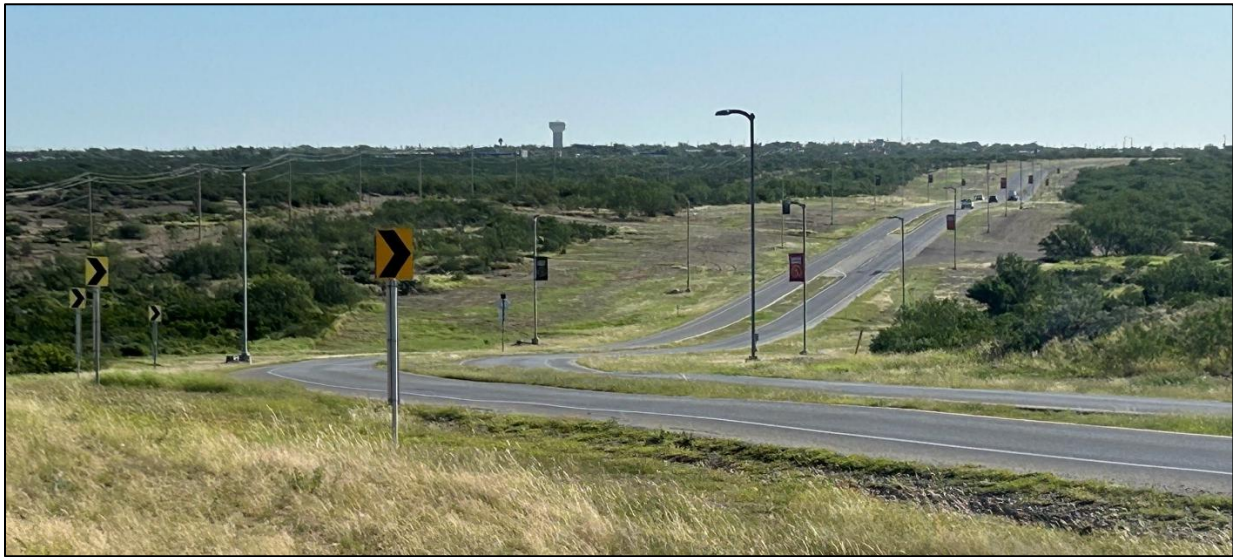
Tierra Soberana Boulevard from El Indo Highway to Grass Valley Road serves as the main access corridor for traffic traveling to and from the Lucky Eagle Casino. This corridor segment had the following safety concerns:

- Observed vehicle speeds higher than the posted speed limit
- Some S-curves without curve chevron signs
- No superelevation in curves
- Wavy pavement with steep dips and crests
- Narrow paved shoulders
- Limited drainage infrastructure
- No turn lanes at side street intersections

Tierra Soberana Blvd. corridor (Source: FHWA)

Of note, the Tierra Soberana Boulevard corridor has planned improvements to include upgrading to a four-lane corridor, installation of superelevation at curves, raised pavement markers, rumble strips, safety edge treatment, curve warning signs, turn lanes at intersections, median streetlights, curbing, gutters, and culverts, among others.

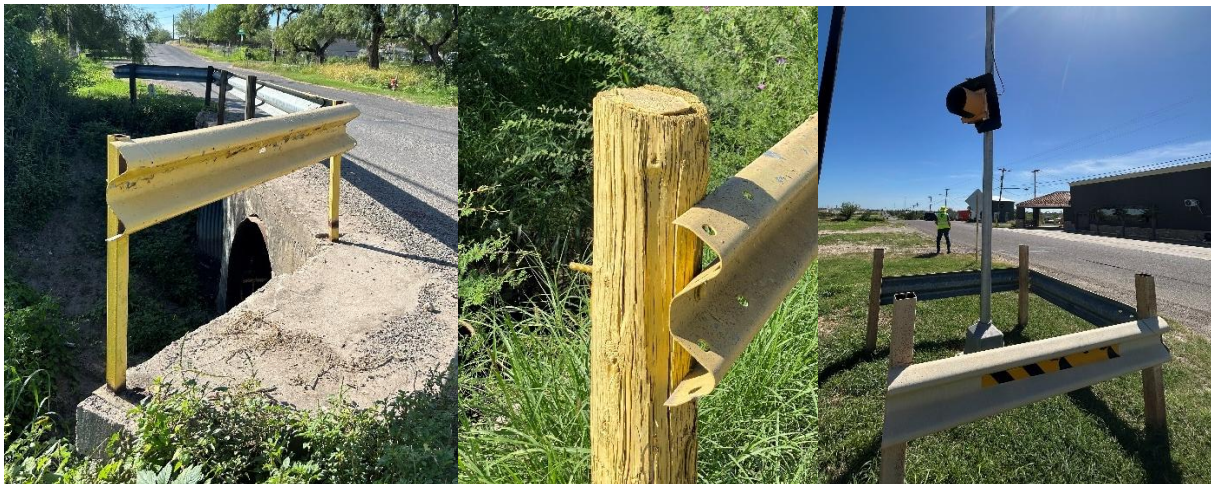
Guard rails on the study corridors appear to be non-engineered and do not meet the AASHTO Roadside Design Guide standards. Key design failures on most existing guard rails include a lack of end treatments, non-standard posts, and non-standard flared terminals.

Study corridor guard rails (Source: FHWA)

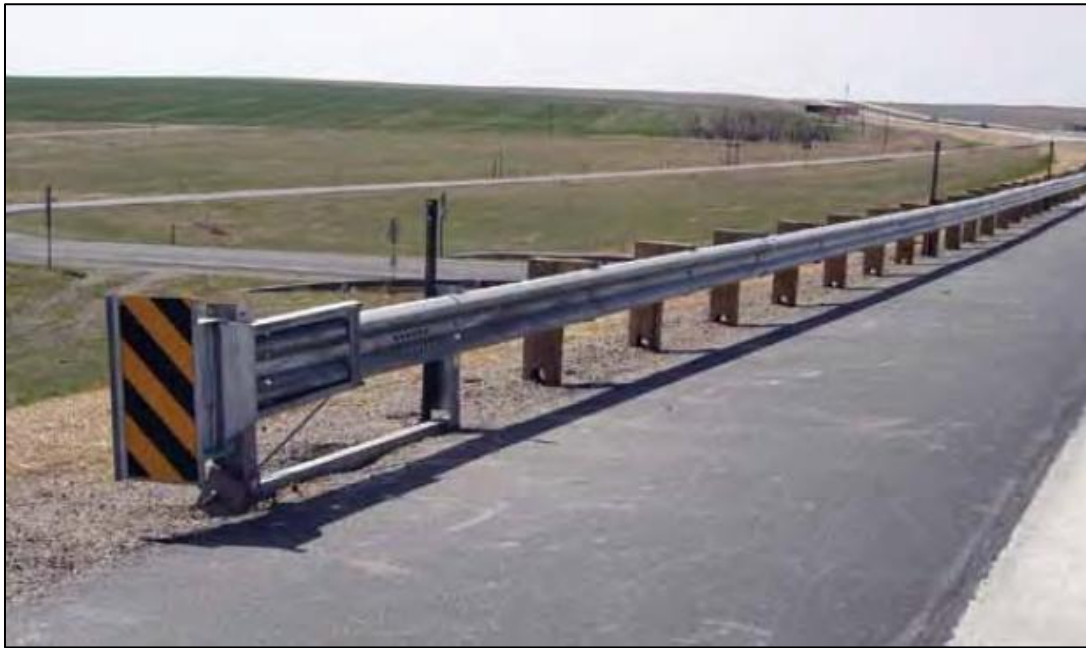
Sample guard rail end treatment and posts (Source: AASHTO Roadside Design Guide 4th Edition)

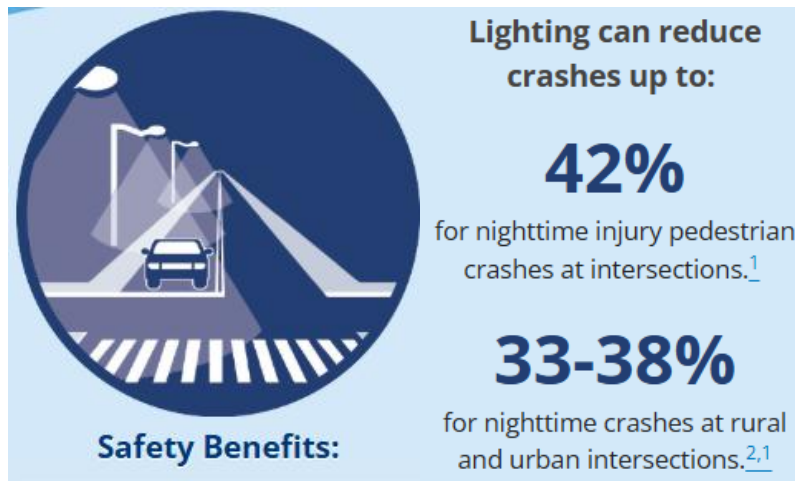
The lighting on Rosita Valley Road from El Indio Highway to Standing Rock Lane was observed to be limited throughout. The lack of lighting in the corridor increases the risk of nighttime collisions, particularly at intersections and road curves. Roadway lighting can reduce overall rural nighttime crashes by up to 38% and 42% for pedestrians at intersections.

Streetlighting benefits (Source: FHWA)

Rosita Valley Rd from El Indio Highway to Standing Rock Lane	County	Street lighting	\$2,200,000	Long-term	Low

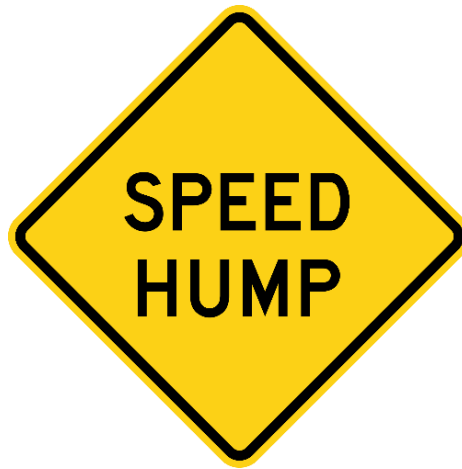
Speed hump warning sign W17-1 (Source: MUTCD)

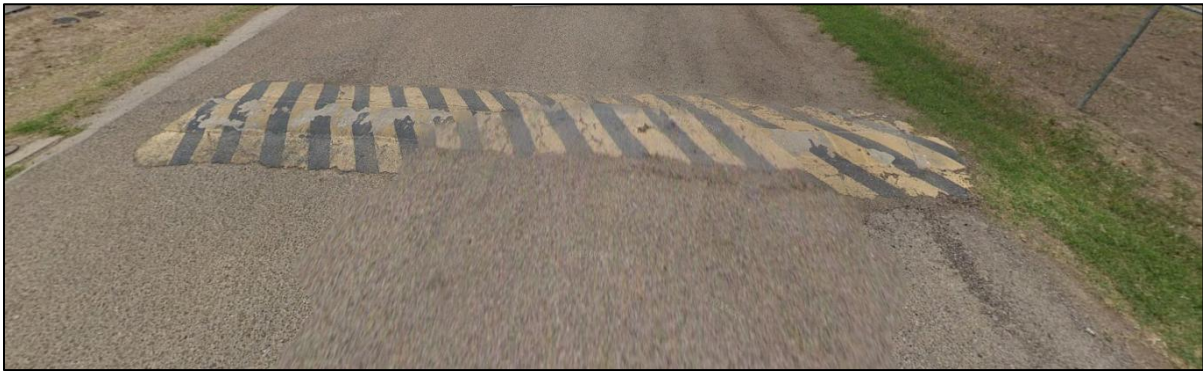
Speed humps were observed throughout the community roadways. Some speed humps had faded or non-high-visibility pavement markings. Limited speed hump warning signage was observed in advance of speed hump placement on roadways such as Tierra Soberana Boulevard and Lucky Eagle Drive.

Sample speed hump observed (Source: Google)

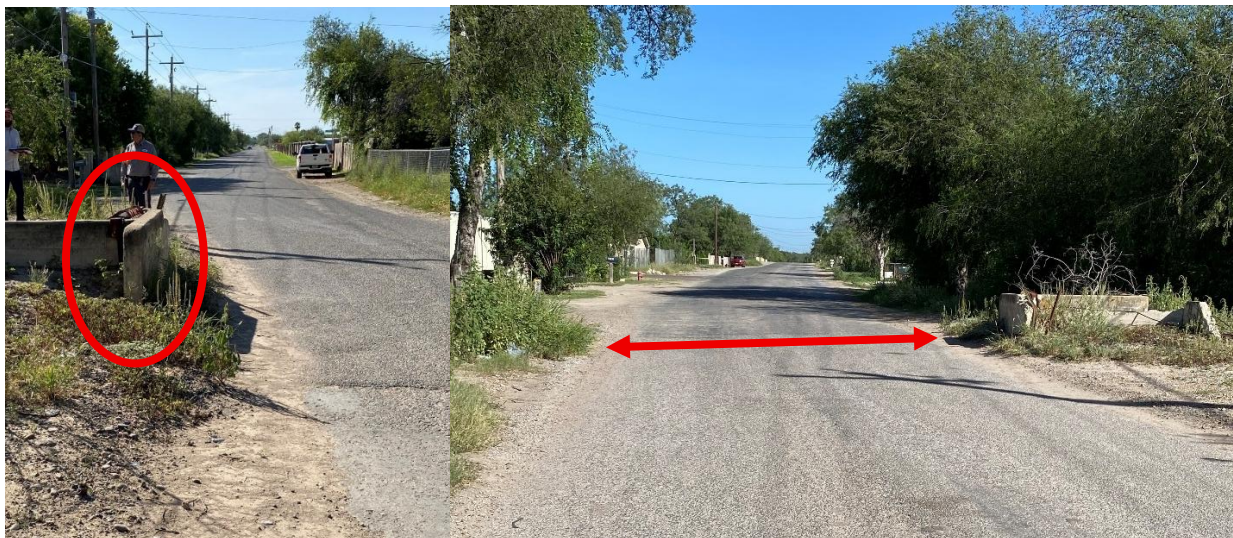
A narrow passage on Rosita Valley Road, approximately 180 feet southwest of Garcia Drive, has unprotected concrete headwalls without an object marker or warning signage. The presence of roadside fixed objects within the clear zone of a roadway introduces a hazard to motorists, particularly when not marked with signage or shielded by guardrail.

Unprotected headwalls at narrow passage on Rosita Valley Road (Source: FHWA)

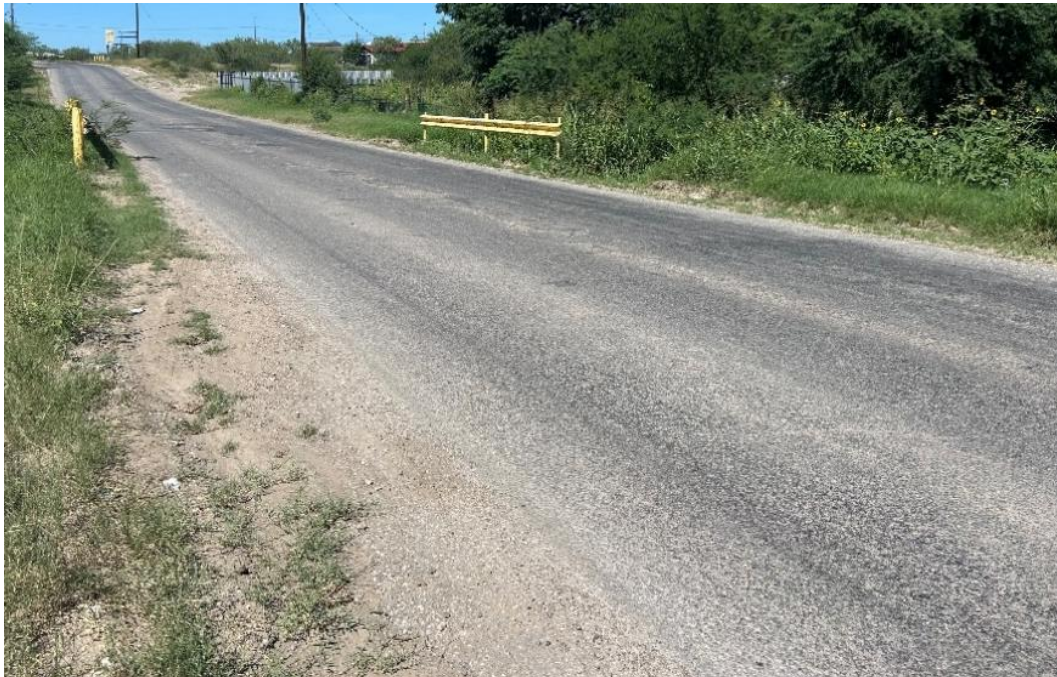
Rosita Valley Road is a main access road to the Tribe that is classified as a major collector by the TxDOT. Throughout the corridor, there are no centerline or edge line markings to assist motorists in proper lane positioning and to separate the opposing directions of travel. The FHWA MUTCD Chapter 3B.01 guidance states that “centerline markings should also be placed on all rural arterials and collectors that have a traveled way of 5.5 m (18 ft) or more in width and an ADT of 3,000 vehicles per day or greater.”

Rosita Valley Road (Source: FHWA)

IMPROVEMENT TYPE	PROJECT LOCATION	Jurisdiction	Scope	Probable Cost*	Timeline	Priority
Markings and Delineation	Rosita Valley Rd from El Indio Hwy to Lucky Eagle Rd	County	Install centerline and edge line markings	\$180,000	Near-term	Medium
Corridor Speed	Tierra Soberana Blvd from El Indio Hwy to Grass Valley Rd, Rosita Valley Rd from El Indio Hwy to Lucky Eagle Rd	County	Install speed feedback signs	\$75,000	Near-term	High
	Tierra Soberana Blvd and Rosita Valley Rd	Tribe/County	Conduct targeted speed enforcement campaigns	N/A	Near-term	High
	Tierra Soberana Blvd and Lucky Eagle Dr	Tribe/County	Install speed hump warning signs (W-17) and speed hump high-visibility pavement markings	\$50,000	Near-term	Medium
Pavement	Tierra Soberana from El Indio Hwy to Grass Valley Rd	County	Install paved shoulders	\$12,500,000	Mid-term	Medium
	Regan Street at the Transportation Department (1,500 feet southeast of Democracy St)	Tribe/County	Install off-street parking stalls	\$350,000	Long-term	Medium

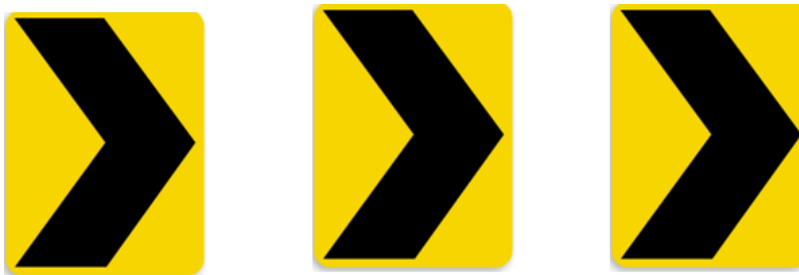
Curve warning signs, chevrons, and curve delineation improve driver awareness of tight horizontal roadway curves. These features were intermittently found in the study area but are absent on the Tierra Soberana Boulevard S curve just north of the Casino, and on Rosita Valley Road. Chevron alignment signs (W1-8) and delineator placement examples are shown below.

Chevron alignment signs (W1-8) (Source: FHWA MUTCD)

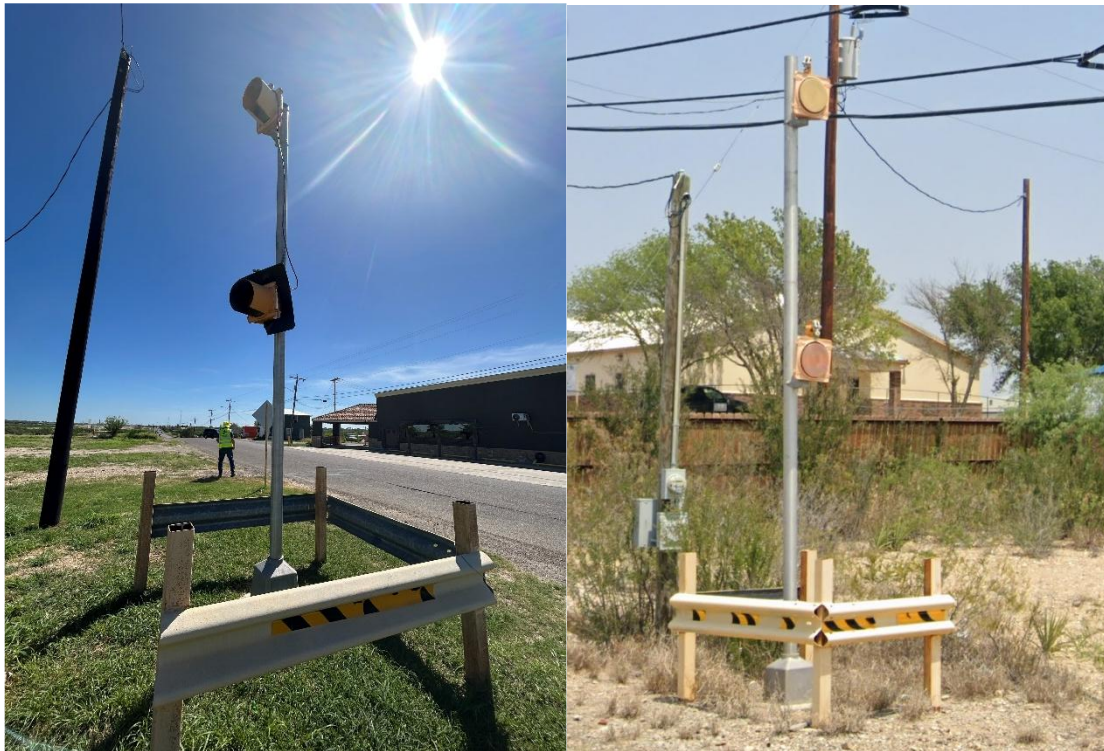
To the north and south of Rosita Valley Elementary School on Rosita Valley Road, there are damaged and non-functional flashing beacons with suspected missing school zone signs. The replacement or repair of these enhanced school zone warning signs will improve motorists' awareness of potential school-aged children in and along the roadway near the elementary school.

Rosita Valley Road damaged and missing school zone signs and flashing beacons (Source: FHWA)

School Zone	Rosita Valley Road at Rosita Valley Elementary School	County	Repair/replace existing flashing beacons and school zone signage (S1-1 and W16-9P)	\$60,000	Mid-term	High
Intersections	Tierra Soberana Blvd/County Rd 253 and Tierra Soberana Blvd/Wagon Wheel Rd	County	Install turn lanes	\$270,000 each	Mid-term	Low
	Kurt Bluedog Rd and Chick Kazen St	Tribe	Relocate stop signs closer to the intersection and install no-parking signs at the intersection	\$30,000	Near-term	High
Systemic	Regan St 1,500 feet southeast of Democracy St, Rosita Valley Rd 180 feet southwest of Garcia Drive, Rosita Valley Rd 500 feet northeast of Los Guajillos St, Rosita Valley Rd 150 feet southeast of Standing Rock Ln	County	Install/replace guardrails	\$150,000	Near-term	High
	Tierra Soberana Blvd, Rosita Valley Rd curves	County	Install roadway delineators and curve chevron signs (W1-8)	\$45,000/curve	Mid-term	High

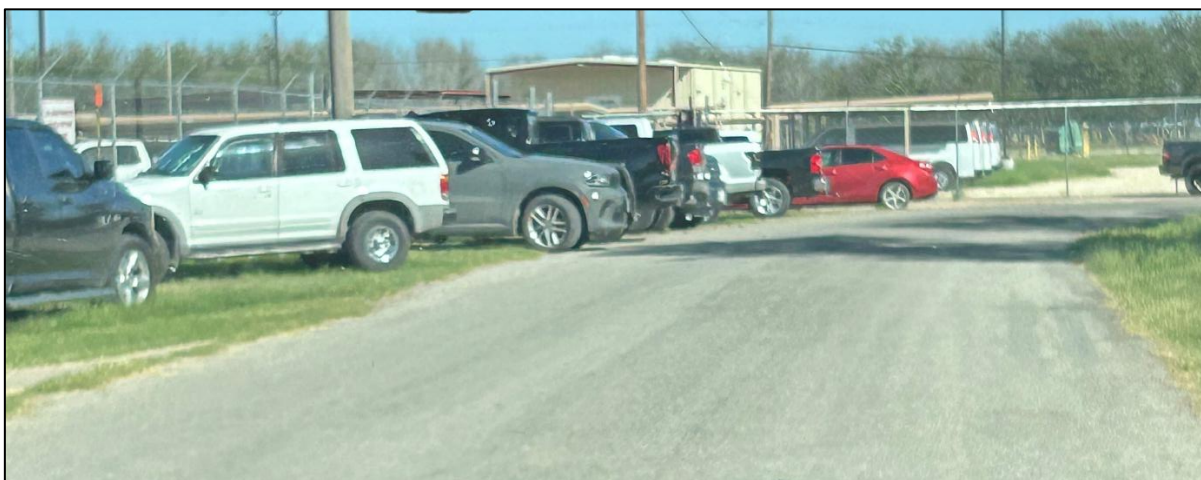
Parked vehicles along Regan Street at the Transportation Department extended into the roadway, creating unsafe conditions as shown in the image below. Parking on the road narrows travel lanes and creates sight obstructions. The extent of the parked vehicles is shown in the red zones in the map below. A dedicated parking location set back from the roadway would be more appropriate.

Parking on Regan Street (Source: FHWA)

Regan Street on-street parking locations (Source: Google)

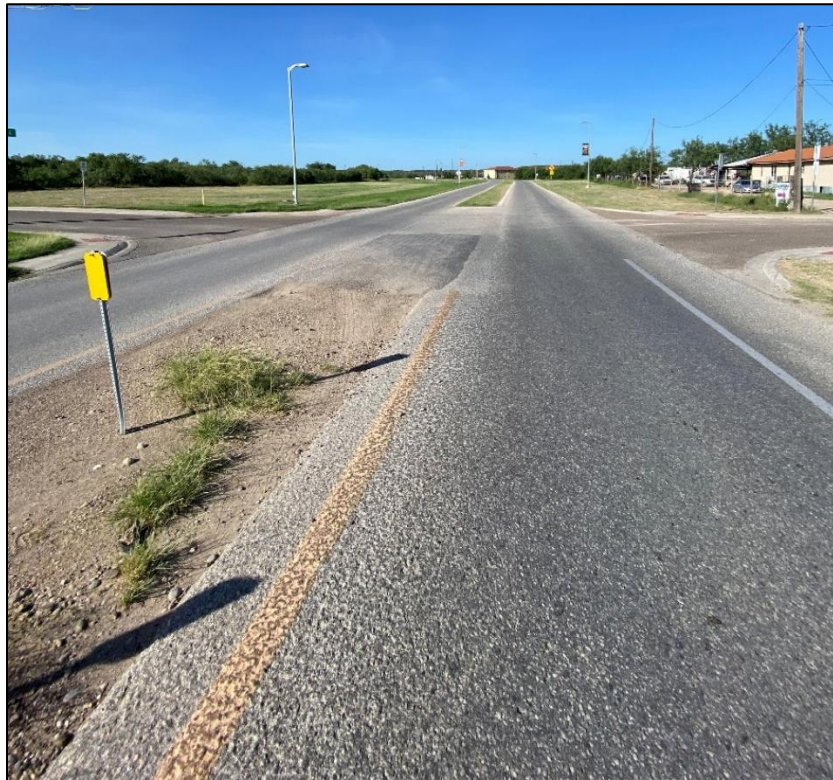
Few turn lanes were observed at major route intersections. Some intersections on Tierra Soberana Boulevard and Rosita Valley Road appear to receive adequate traffic to justify turn lanes. Turn lanes would have the effect of reducing conflicts between turning and through traffic on the route. This conflict was noted particularly at the intersection of Tierra Soberana Boulevard and County Road 253. There is also a crash history at this intersection.

Tierra Soberana Blvd at County Road 253 looking south (Source: FHWA)

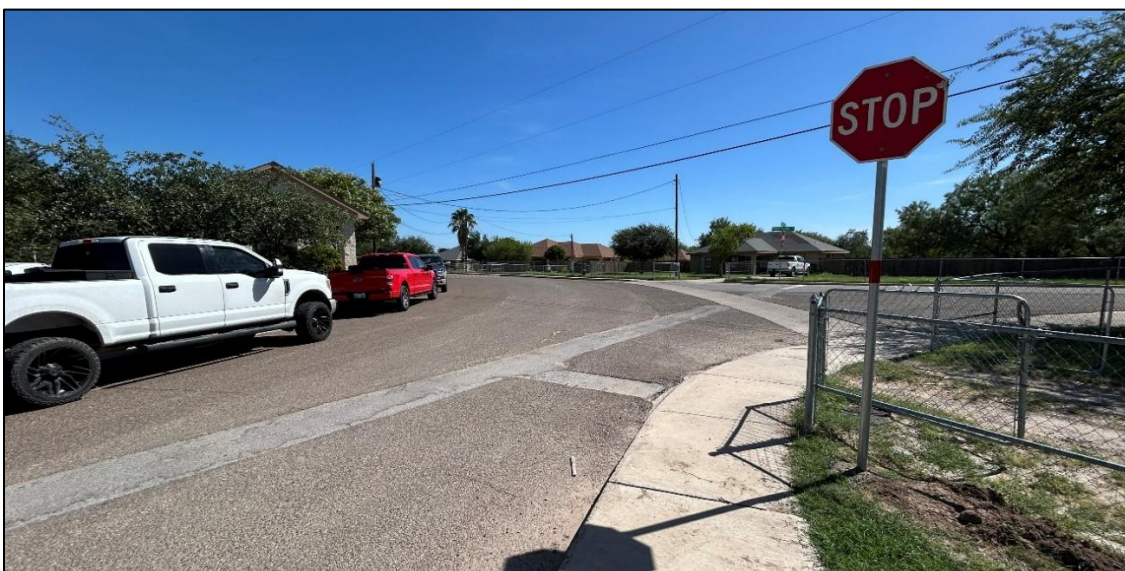
The turning sight distance at the intersection of Kurt Bluedog Road and Chick Kazen Street appeared inadequate. The stop-controlled eastbound leg enters the intersection at a skew, with its stop sign placement back from the intersection. The presence of a building on the northwest corner limits the sight distance at the intersection. Paring is also present in the intersection on the northwest corner, further reducing sight distance when vehicles are parked. Signing of no parking

Aerial view of the Kurt Bluedog Road and Chick Kazen Street intersection (Source: Google)

Kurt Bluedog Road and Chick Kazen Street intersection looking northeast (Source: FHWA)

and relocating the stop signs closer to the intersection would help mitigate the sight distance deficiencies.
